HPDE Technical Inspection Form

Technical Note: BMW Power Steering Line Failures

Technical Note: Wheel Bolts/Studs/Nuts

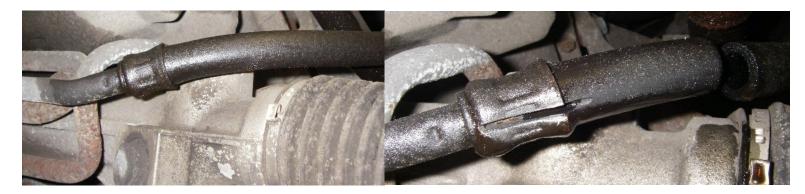
You should also seriously consider replacing the power-steering-return hose with a suitable piece of hose a few centimeters longer. BMW hose # 32-41-1-131-524 [12-mm ID (inside diameter), cut to length] is known to work in this application. You will also need two hose clamps # 11-15-1-727-509 [15-18-mm]. Some claim success with aftermarket high-temperature hose of ½-inch ID, but be advised that the BMW hose fits the nipple on the steering- cooler more tightly than do some nominal ½-inch ID hoses. In the photo, the ferrule is where the failure occurs.

On-track failures of the power-steering-return hose are of concern on E36 ('92-'99) and E46 ('99-'06) 3-Series BMWs. The failures have all been the same: the return hose separated from the power-steering rack cooler at the factory-crimped connection. This failure results in power-steering fluid being disgorged onto the track in a few seconds, creating a very serious hazard for the afflicted car and following vehicles. Of course, steering power-assist is lost as well. Please note that we have seen replacement OE hose assemblies also fail on their first track session, so replacing the power-steering cooler/return-hose assembly with stock parts has been shown to be ineffective in addressing the problem.

Replacing the return hose is a straightforward operation. After the car has been secured on jack stands or a lift and allowed to cool, begin by cutting the return hose and allowing the contents of the system to drain into a pan. Note that the return hose is the SMALLER of the two hoses attached to the power-steering-fluid reservoir. Then, CAREFULLY slit [as shown in the photo] and remove the ferrule/hose from the power-steering-cooler outlet. An abrasive wheel was used for the photo, but a cutting pliers will suffice. Ensure that the hose nipple under the ferrule is not damaged by the slitting operation. If it is damaged, you will need to procure a new cooler-return- hose assembly.

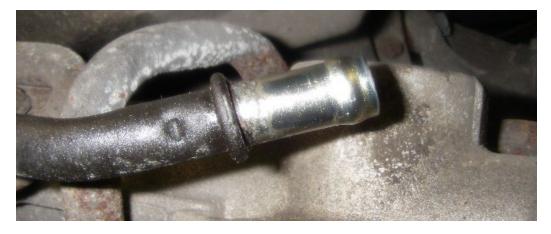
When the ferrule and hose have been removed from the cooler outlet, you should see a hose nipple like this:

Continue by removing the other end of the return hose from the power-steering-fluid reservoir, then cut the new hose to the appropriate length and install to the cooler and reservoir with two hose clamps. You may find that your removed hose contains a restriction orifice located about 10-cm from the reservoir. You can remove this orifice and push it into your new hose, securing the orifice with a third hose clamp. Refill the system with fresh Dexron ATF or other suitable fluid and bleed the system. Check for leaks and you should be done.

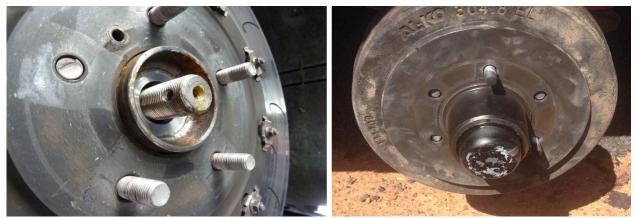
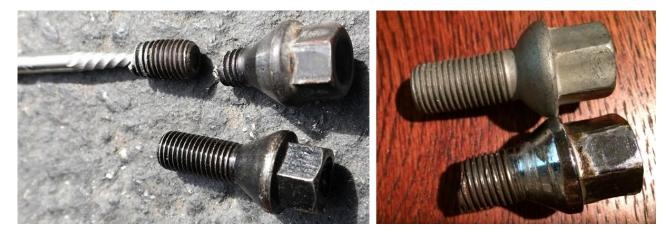
You've prepped your car for the track, got fresh brake pads, have plenty of tread on your tires, new oil and coolant. How about your wheel studs or wheel bolts? Did you know that wheel studs and bolts should be considered wear items, and their replacement should be accelerated on a car that sees track time? Wheel stud failure can lead to a serious accident. It's hard to analyze the studs or bolts yourself, and replacement is relatively inexpensive (less than \$200 per car), so we recommend that you inspect yours frequently and replace yours periodically for peace of mind.
