BMW Car Club  
of America  
Genesee Valley Chapter

# HPDE Technical Inspection Form

### Technical Note: BMW Power Steering Line Failures

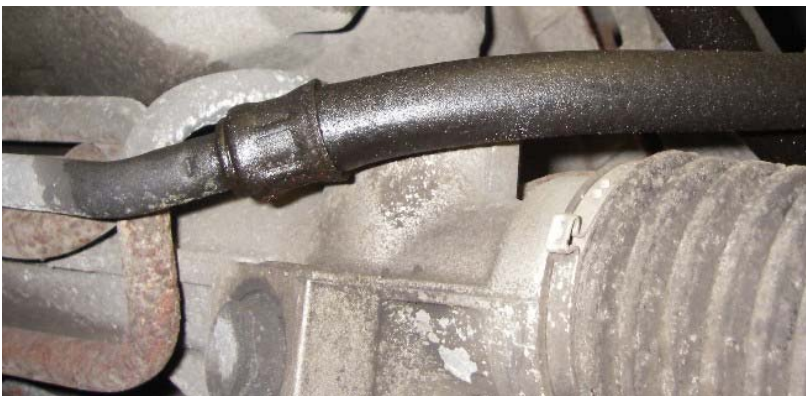
You should also seriously consider replacing the power-steering-return hose with a suitable piece of hose a few centimeters longer. BMW hose # 32-41-1-131-524 [12-mm ID (inside diameter), cut to length] is known to work in this application. You will also need two hose clamps # 11-15-1-727-509 [15-18-mm]. Some claim success with aftermarket high-temperature hose of ½-inch ID, but be advised that the BMW hose fits the nipple on the steering-cooler more tightly than do some nominal ½-inch ID hoses. In the photo, the ferrule is where the failure occurs.

Recently we have seen a number of on-track failures of the power-steering-return hose on E36 (92-99) and E46 (99-06) 3-Series BMWs. The failures we have seen were all the same: the return hose pulled off of the power-steering rack cooler, right at the factory-crimped connection. This failure results in the fluid content of the power-steering system being disgorged in a few seconds, creating a very serious hazard on the track surface for the afflicted car and following vehicles. Of course, steering power-assist is lost as well. Please note that we have seen replacement OE hose assemblies also fail on their first track session, so replacing the power-steering cooler/return-hose assembly with stock parts has been shown to be ineffective in addressing the problem.

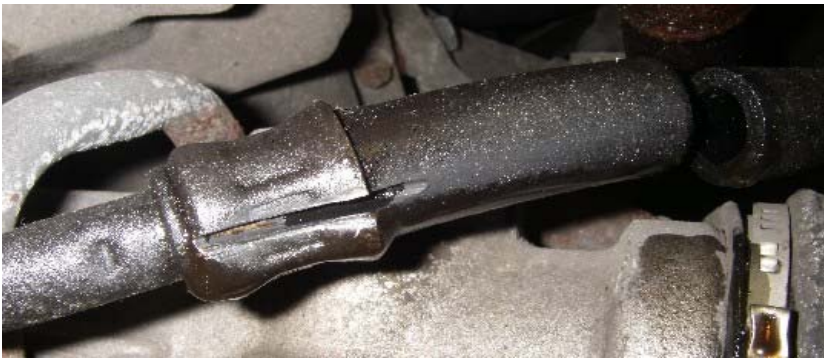
Replacing the return hose is a straightforward operation. After the car has been secured on jack stands or a lift and allowed to cool, begin by cutting the return hose and allowing the contents of the system to drain into a pan. Note that the return hose is the SMALLER of the two hoses attached to the power-steering-fluid reservoir. Then, CAREFULLY slit [as shown in the photo] and remove the ferrule/hose from the power-steering-cooler outlet. An abrasive wheel was used for the photo, but a cutting pliers will suffice. Ensure that the hose nipple under the ferrule is not damaged by the slitting operation. If it is damaged, you will need to procure a new cooler-return- hose assembly.

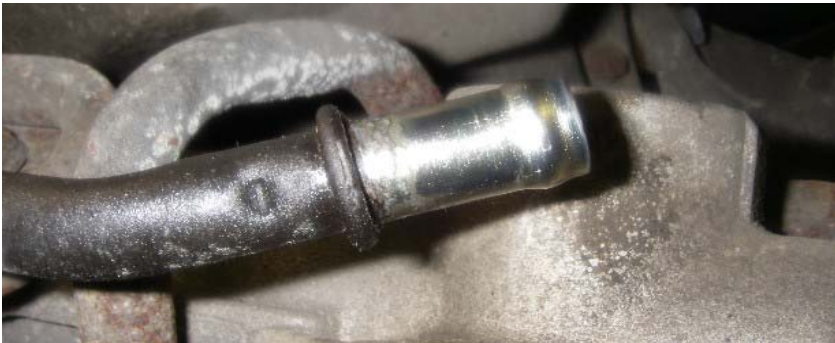
When the ferrule and hose have been removed from the cooler outlet, you should see a hose nipple like this:

Continue by removing the other end of the return hose from the power-steering-fluid reservoir, then cut the new hose to the appropriate length and install to the cooler and reservoir with two hose clamps. You may find that your removed hose contains a restriction orifice located about 10-cm from the reservoir. You can remove this orifice and push it into your new hose, securing the orifice with a third hose clamp. Refill the system with fresh Dexron ATF or other suitable fluid and bleed the system. Check for leaks and you should be done.
